Dauphin Island Northside Restoration Public Information Meeting

March 5, 2020 – 6:00 PM CT

Purpose – Northside Restoration

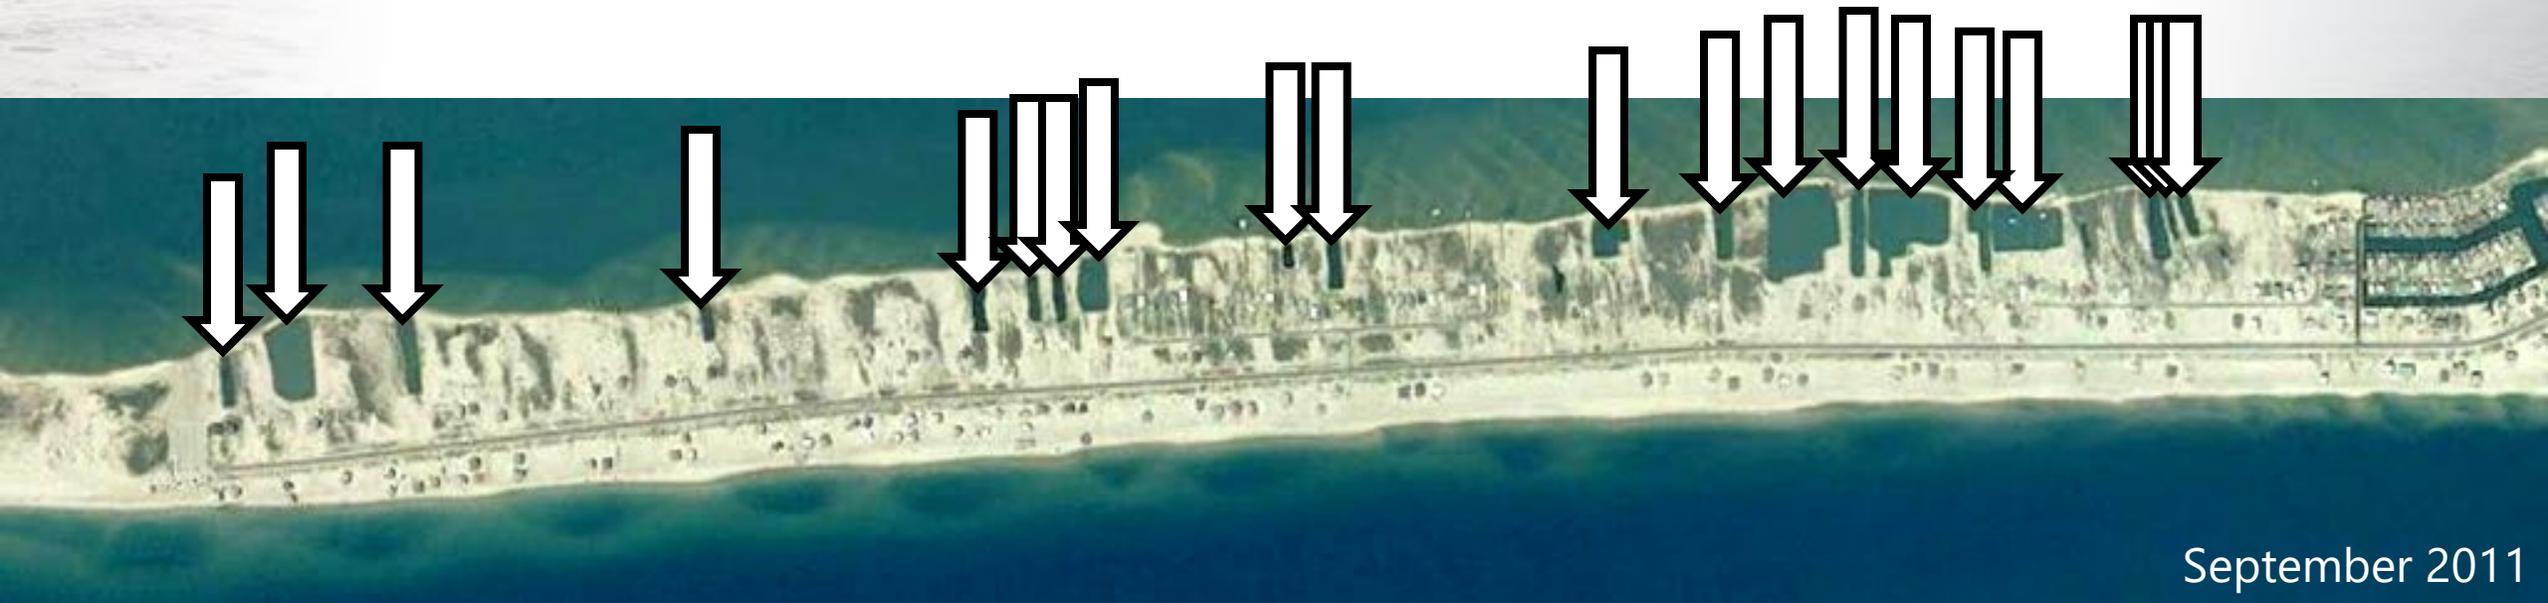
September 2011

Background – Original Borrow Pits

- Sand originally dug from ~20 pits over ~72 individual properties in 2010

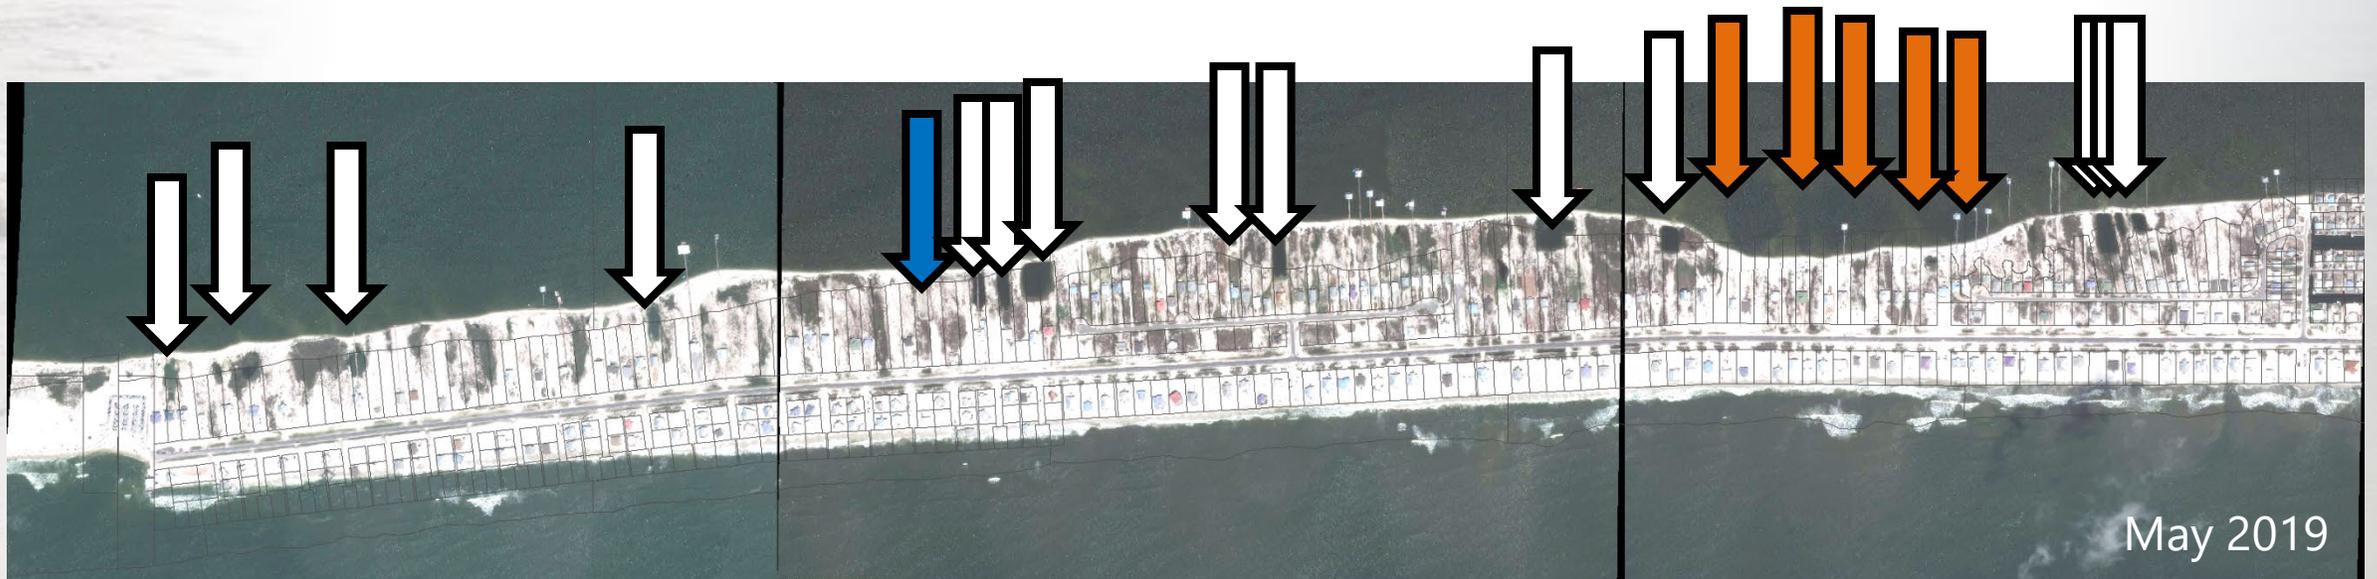
Background – Current Borrow Pits

- 14 distinct inland pits still present, 1 pit filled by owner
- 5 pits have merged/opened into Mississippi Sound

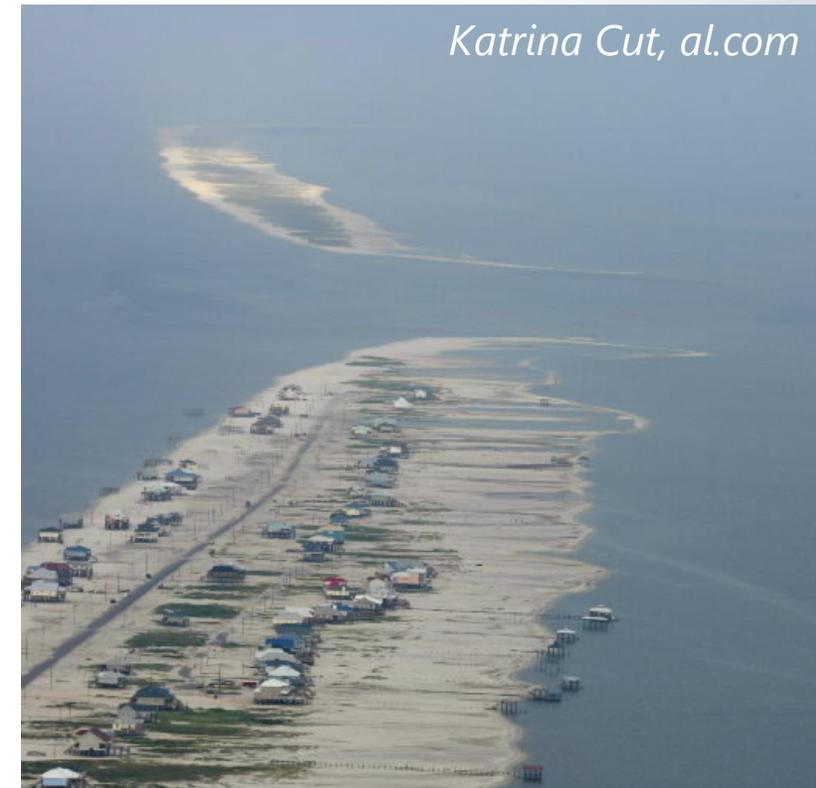
Background – Barrier Island Breaching

- Breaching can occur when barrier islands overwash, removing sand and opening a channel through the island
- Islands tend to breach where they are **low in elevation** and **narrow in width**
- Dangers of a breach on an inhabited island: catastrophic property damage, loss of access, infrastructure damage, economic disaster, possible loss of life

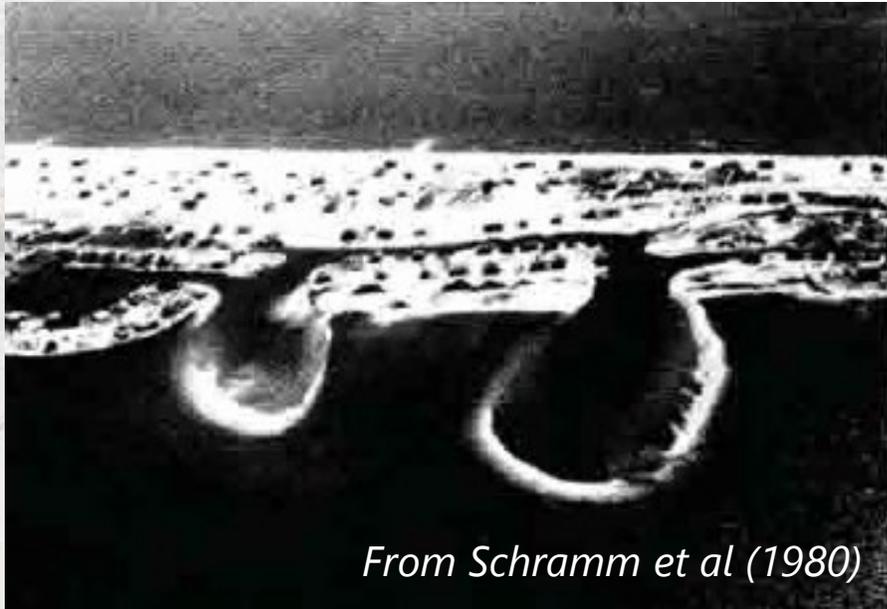
From Schramm et al (1980)

- The West End of Dauphin Island has breached many times in the past, including in 1863, 1916, 1947, 1979, 2004, & 2005

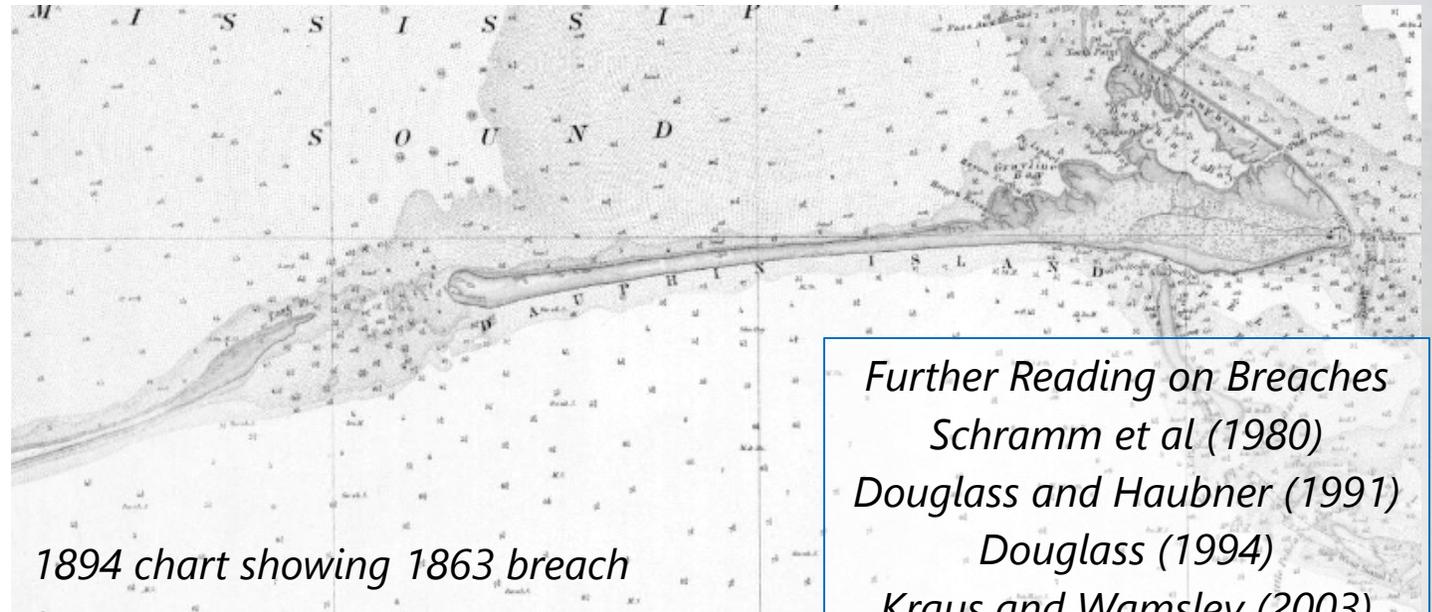
1894 chart showing 1863 breach

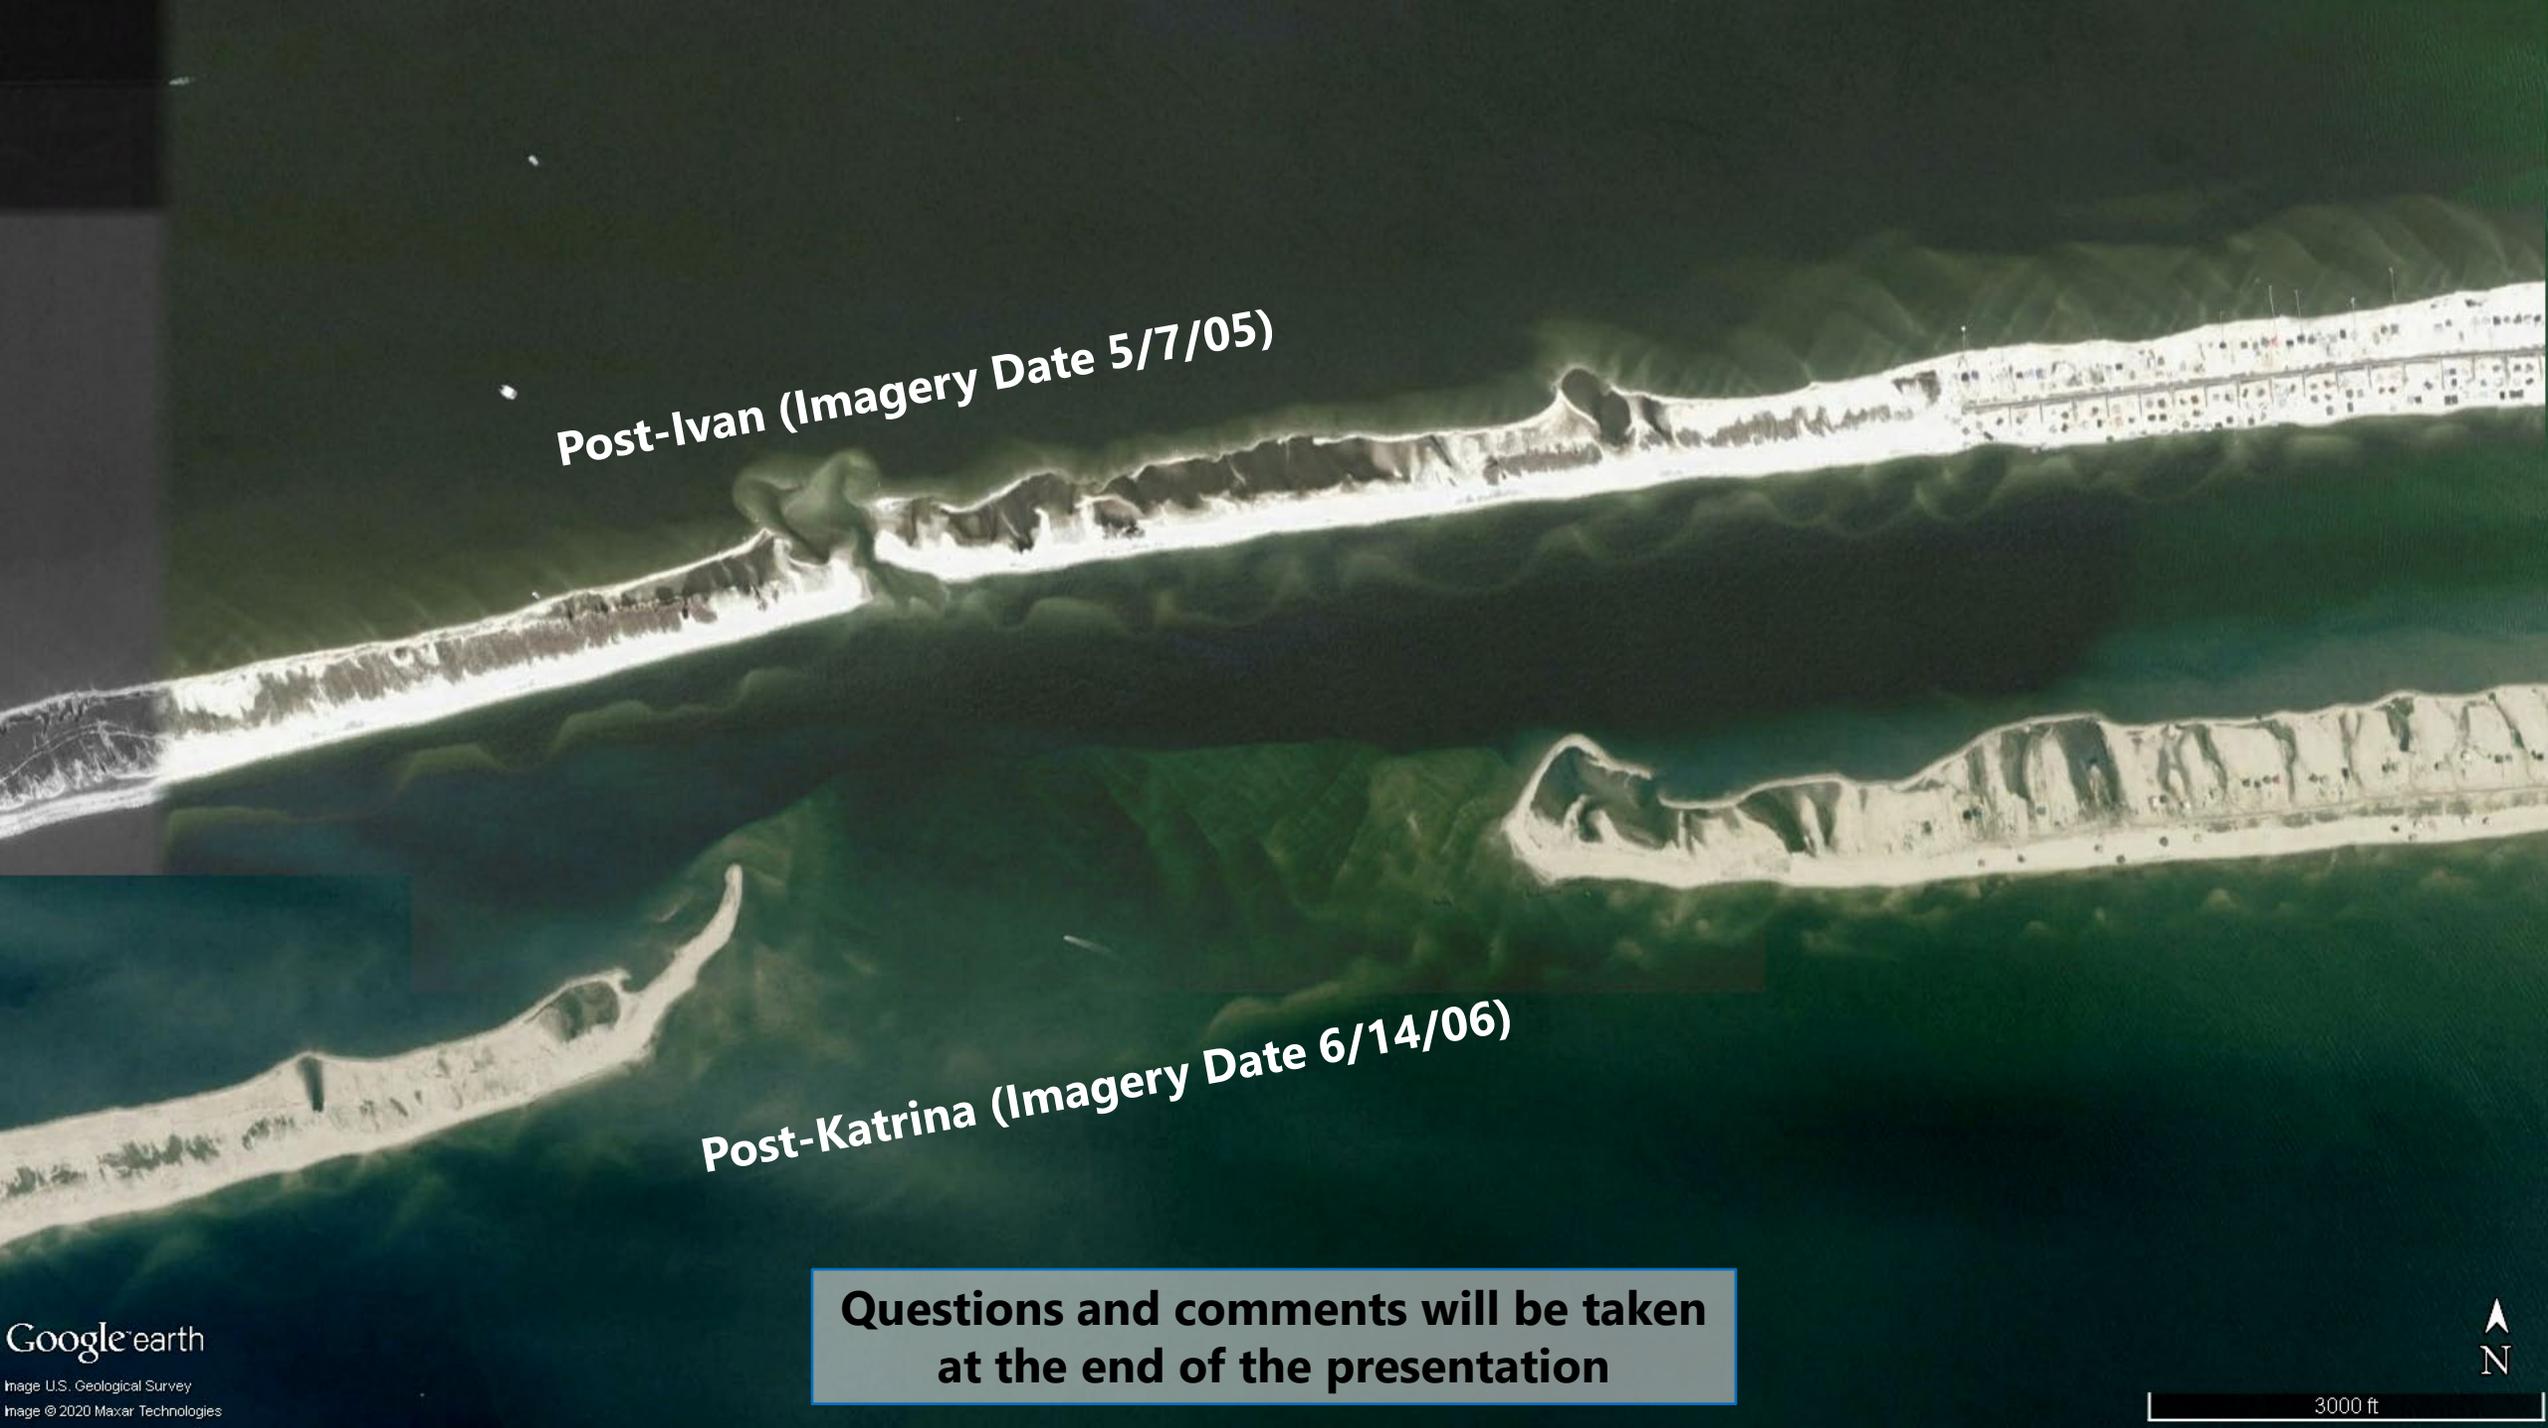
Post-Ivan (Imagery Date 5/7/05)

Post-Katrina (Imagery Date 6/14/06)

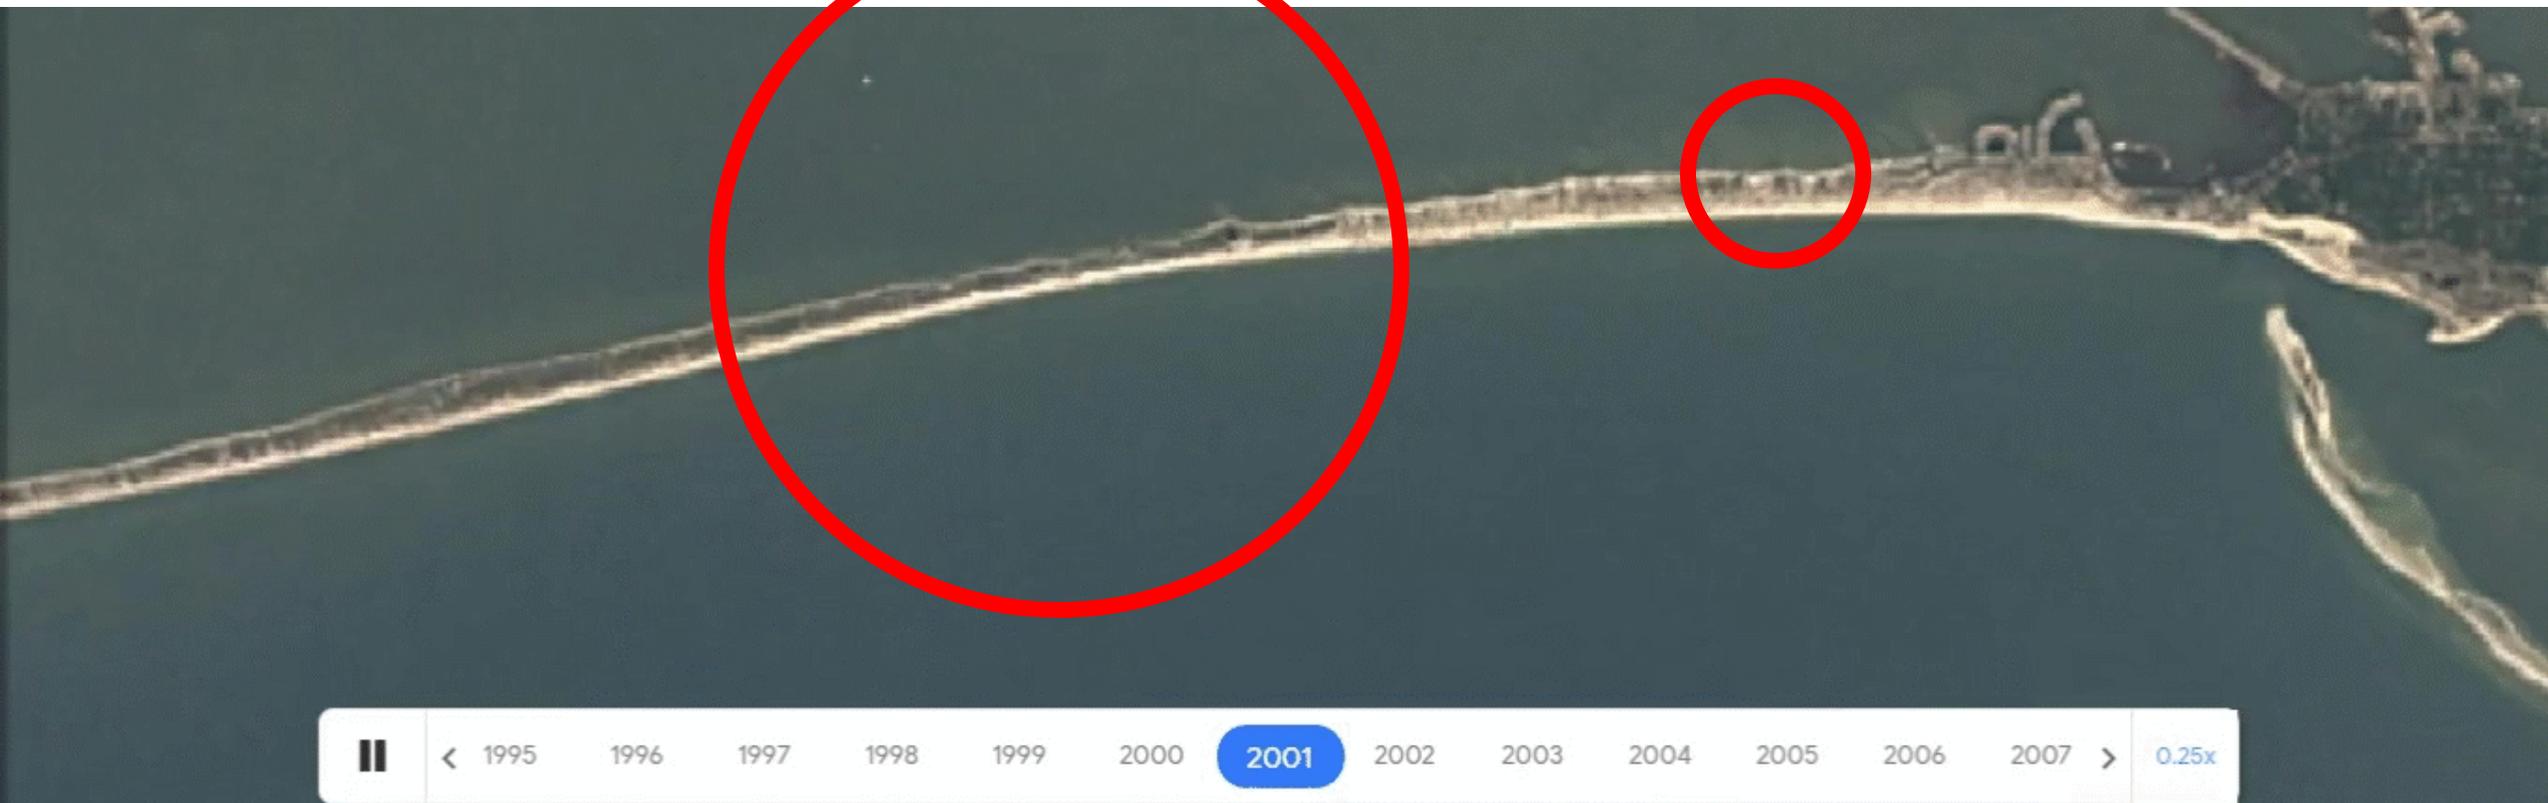
Timelapse of Katrina Cut – 2000-2018

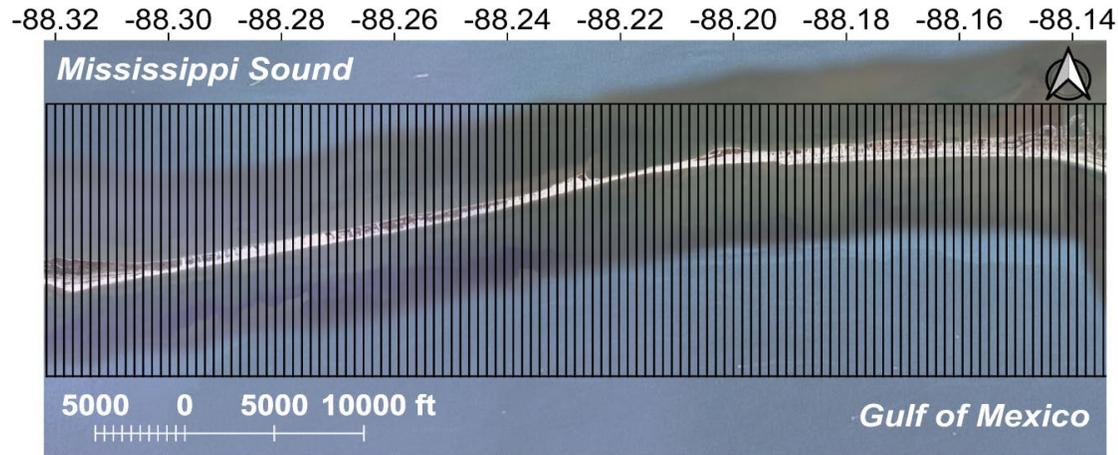
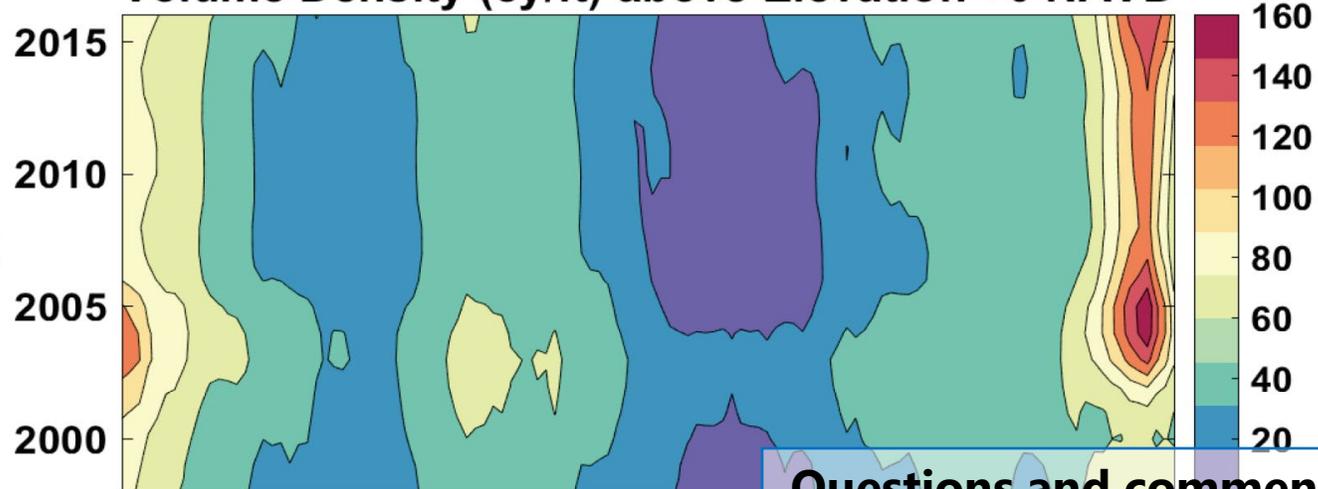
West End Volume Density Timestack

Volume Density (cy/ft) above Elevation +0 NAVD

- LIDAR surveys used to evaluate cross-shore volume density of sand (the amount of sand in a "slice" of the island)
- Breaches most likely in "cooler" colored areas
- Katrina Cut now stabilized with large rocks

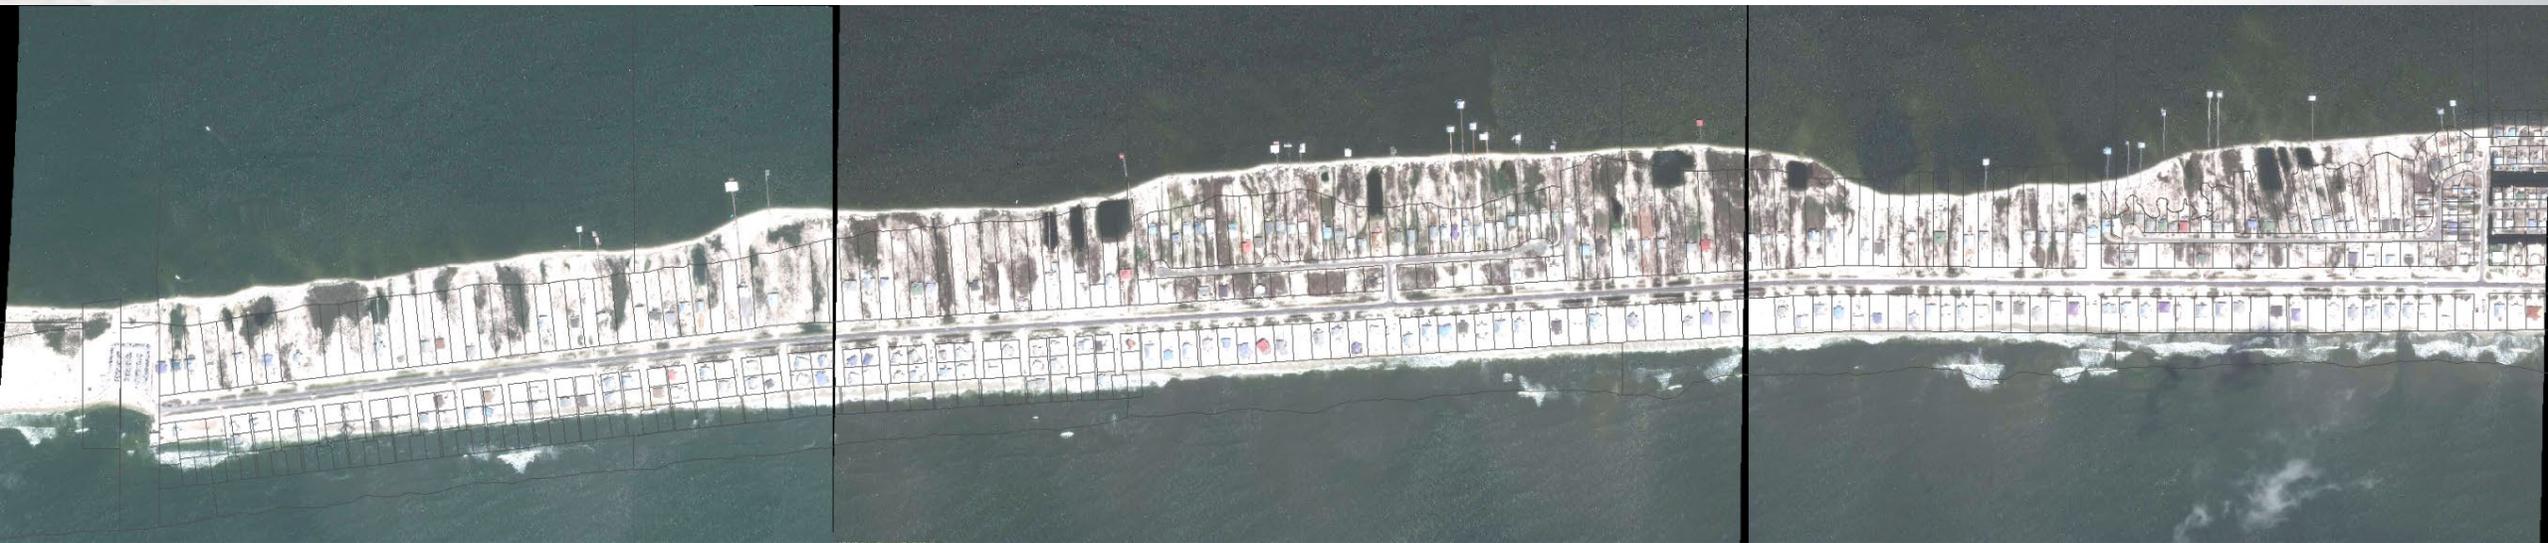
- Goal: Increase the island's resilience to breaching by filling the 2010 pits with clean beach sand
